CONNECTICUT
DEPARTMENT
OF
TRANSPORTATION

CONDITION INSPECTION
FOR THE
BEACON FALLS STATION

**CONN. DEPT OF TRANSPORTATION
STATION INSPECTION**

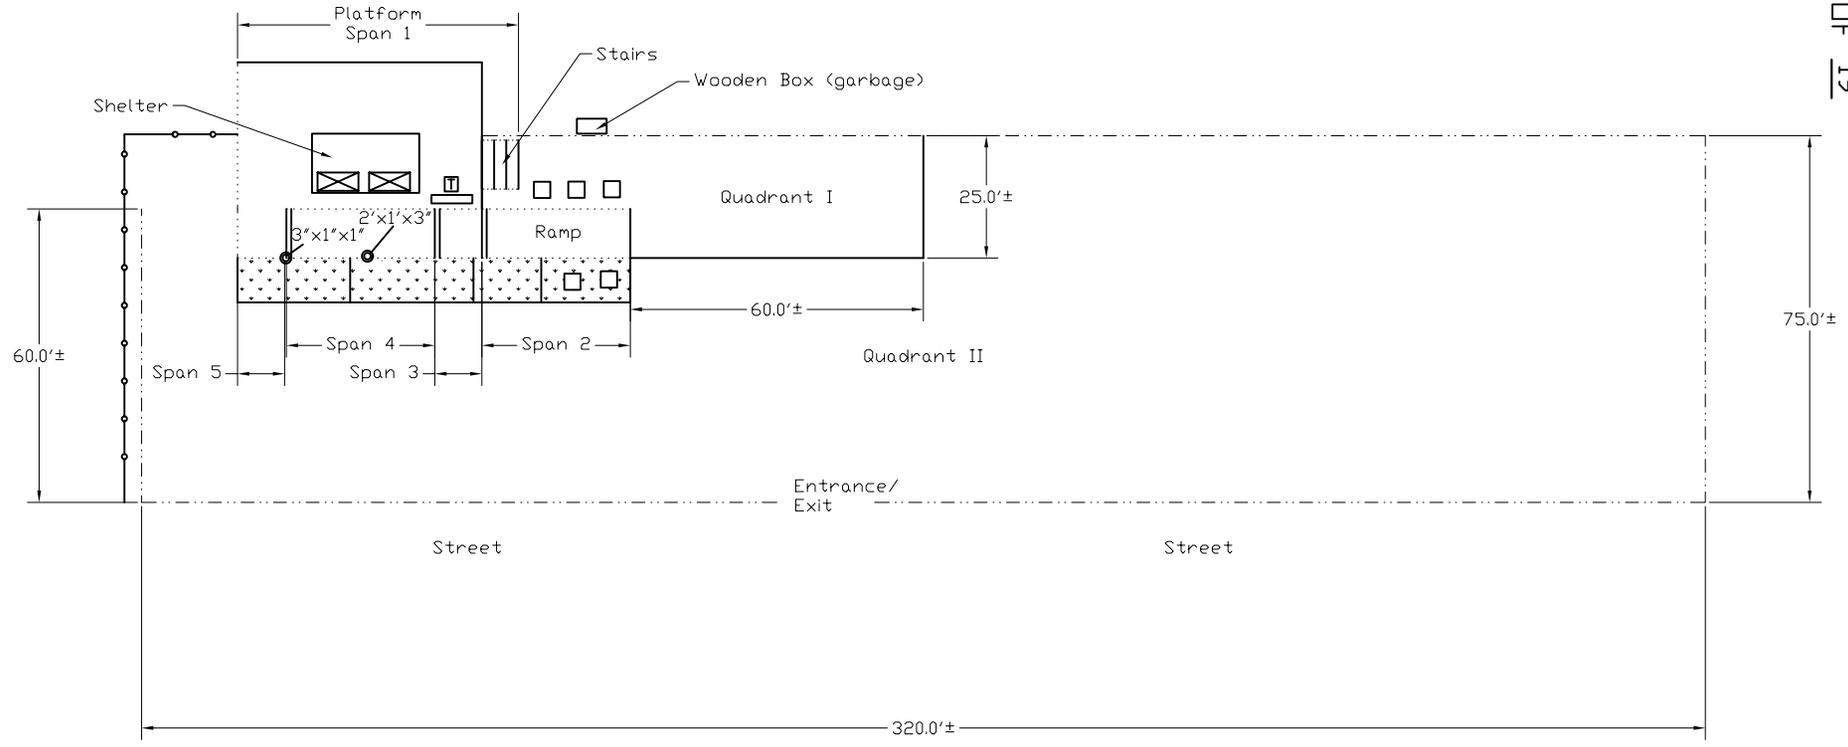
Urbitran Associates, Inc.
Connecticut Dept. of Transportation
Beacon Falls Station General Plan
Date: 11-19-01

- NOTES:
1. The riding surface in Quadrant I is asphalt pavement.
 2. The riding surface in Quadrant II is gravel.
 3. The entire pedestrian railing is rusted.

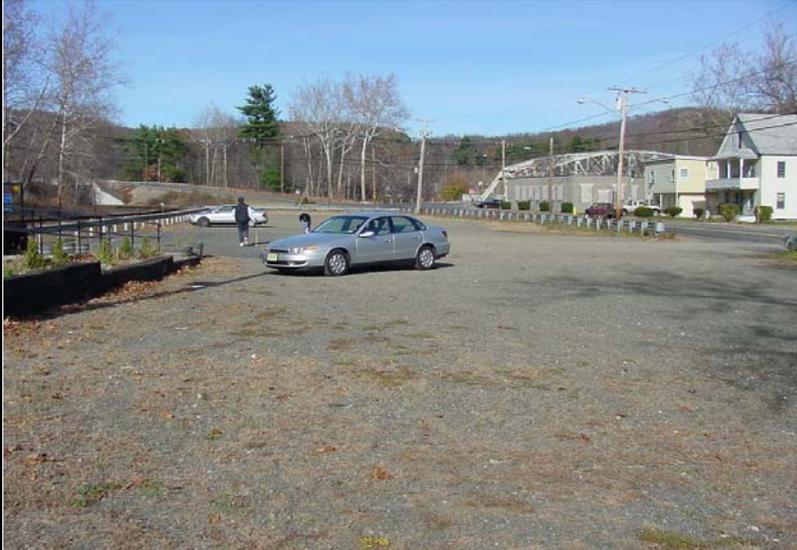
PHOTO NO. 3

Description: _____
General view of the
parking lot
Note the vegetation
growth in the gravel lot

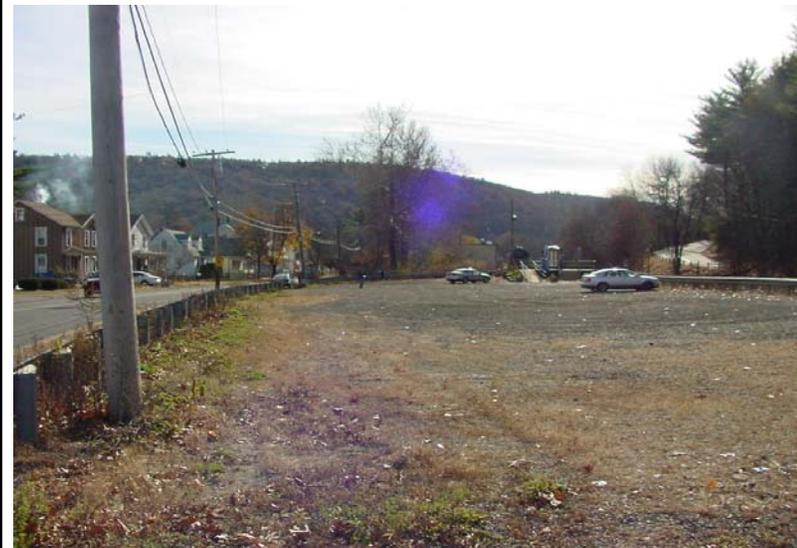
PHOTO NO. 4

Description: _____
General view of the
parking lot
Note the vegetation
growth in the gravel lot

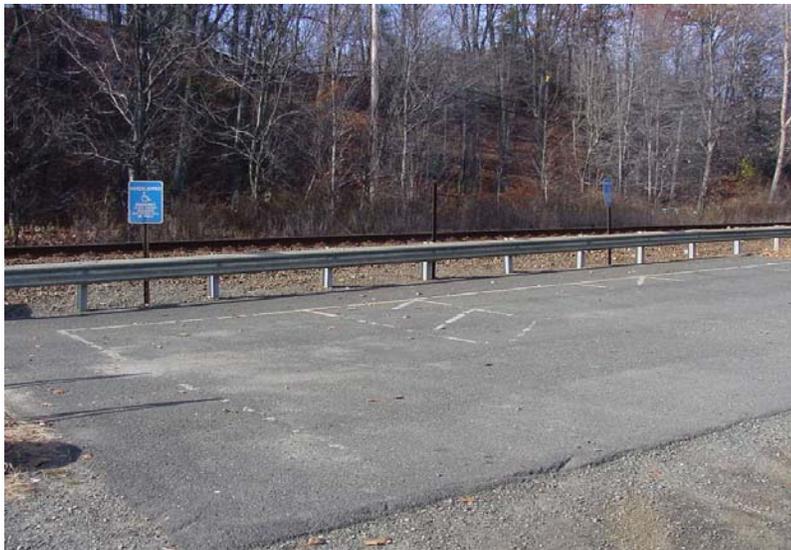
PHOTO NO. 5

CONDITION OF STRIPING: 1

SIGNAGE: 2

Description: General view of Quad I with faded striping and missing handicap sign

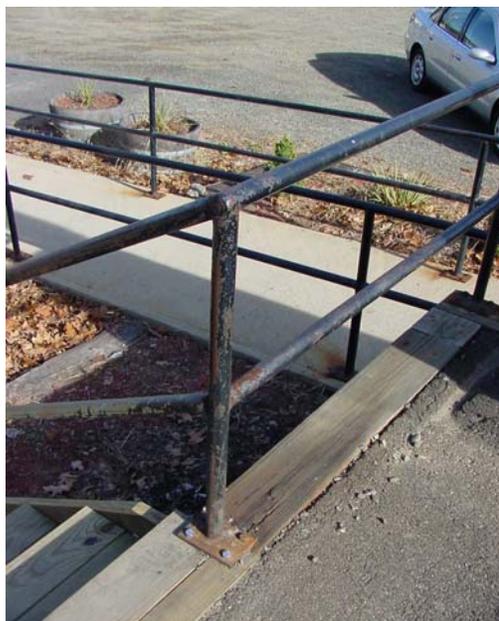
PHOTO NO. 6

Description: The railing is rusted which is typical throughout the platform

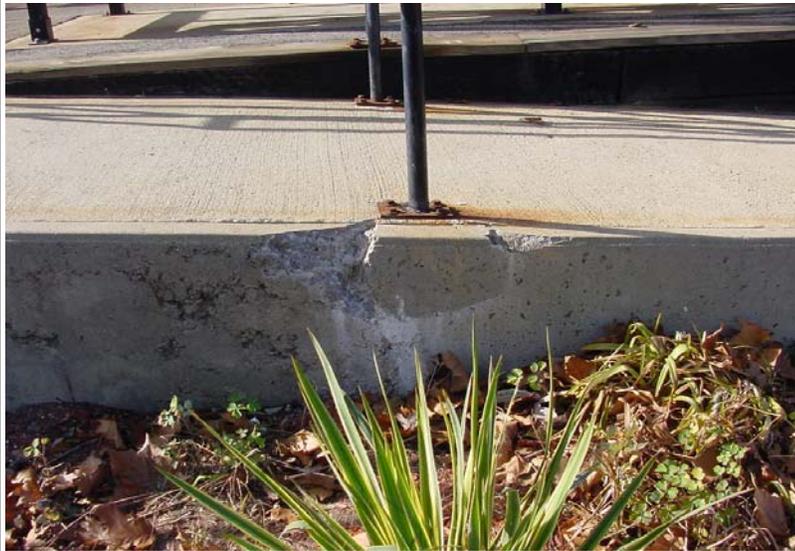
PHOTO NO. 7

Description: _____
An area (2'x1'x3') of the
concrete ramp in span
IV is spalled

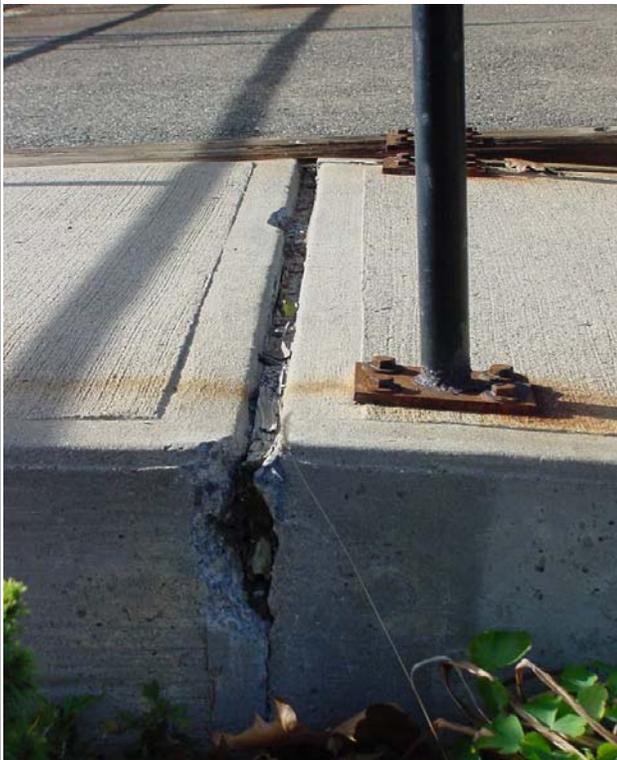
PHOTO NO. 8

Description: _____
In addition to the miss-
ing joint filler material in
Span IV adjacent to the
joint is spalled

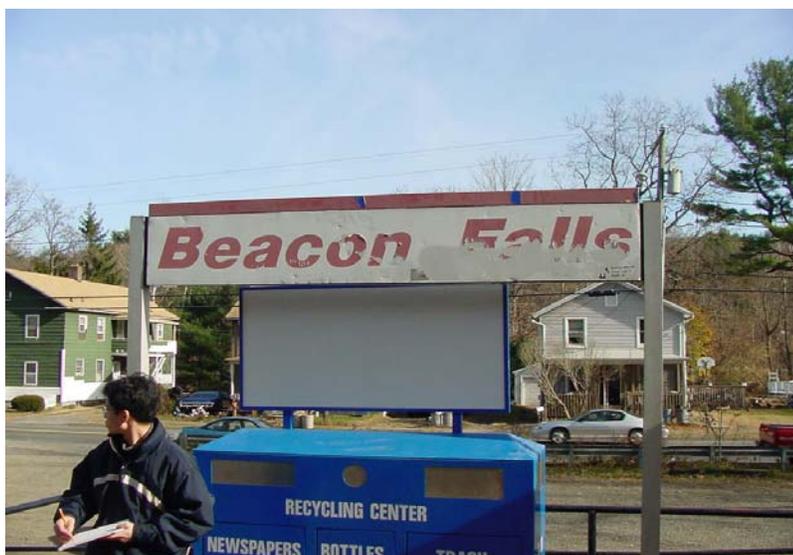
PHOTO NO. 9

Description: A section of the sign text is missing

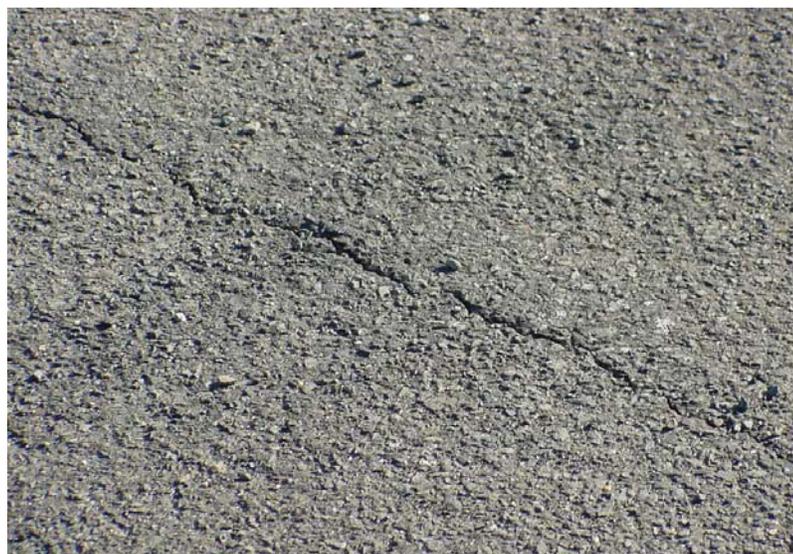
PHOTO NO. 10

Description: Typical crack in Quad I

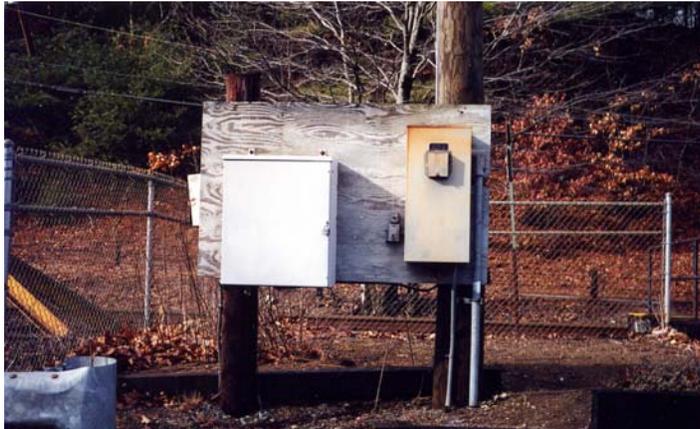
PHOTO NO. 12

The electrical service is mounted in an outdoor enclosure on the utility pole adjacent to the platform. The enclosure is normally locked, but Metro North Railroad electricians were performing routine maintenance and allowed us access to the panelboard enclosure. The panelboard in the enclosure is in good working condition and is more than adequate for this station platform.

Description:
electrical service enclosure

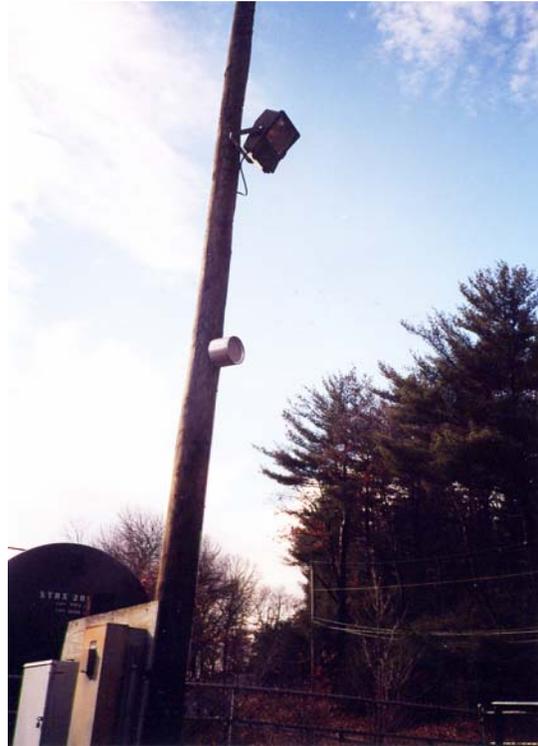
PHOTO NO. 13

Remarks: A typical section of the platform was measured at the location indicated and found to average
13.6 fc.
The platform relies on a utility pole mounted flood luminaire located in the parking area
to illuminate the platform.

There is one floodlight mounted on the service pole that illuminates the platform. This floodlight maintains 13.6 foot-candles, which is above the minimal platform light levels as recommended by the IESNA.

Description:
platform lighting
and speakers

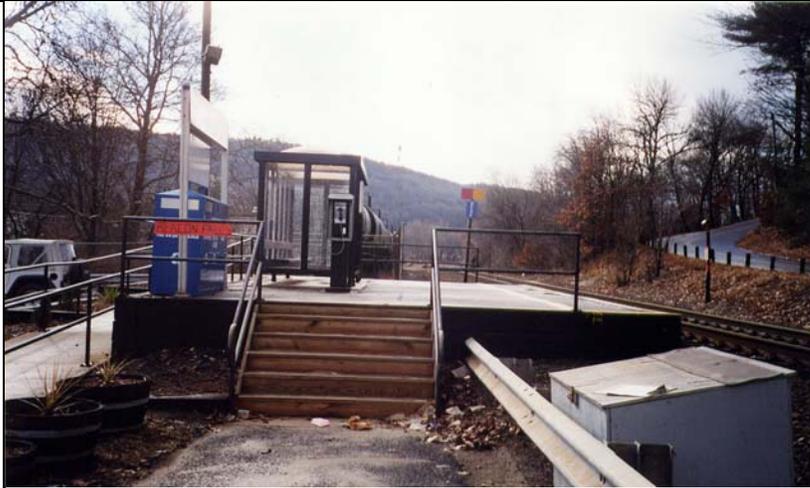
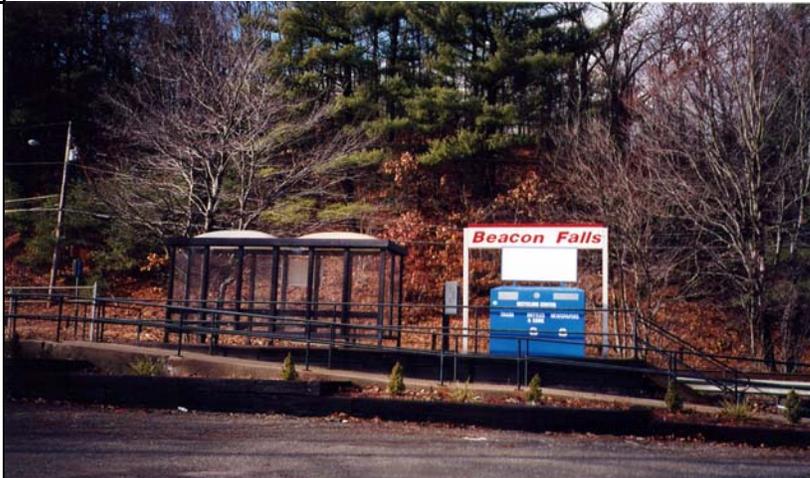
There are two small shelters with plastic curbed roofs. There are no gutters or downspouts.
There is no maintenance required.

Description:
Platform shelter
